HO-1081

8680 Pine Road
Private

Maryland Inventory of Historic Properties Form

Inventory No. HO-1081

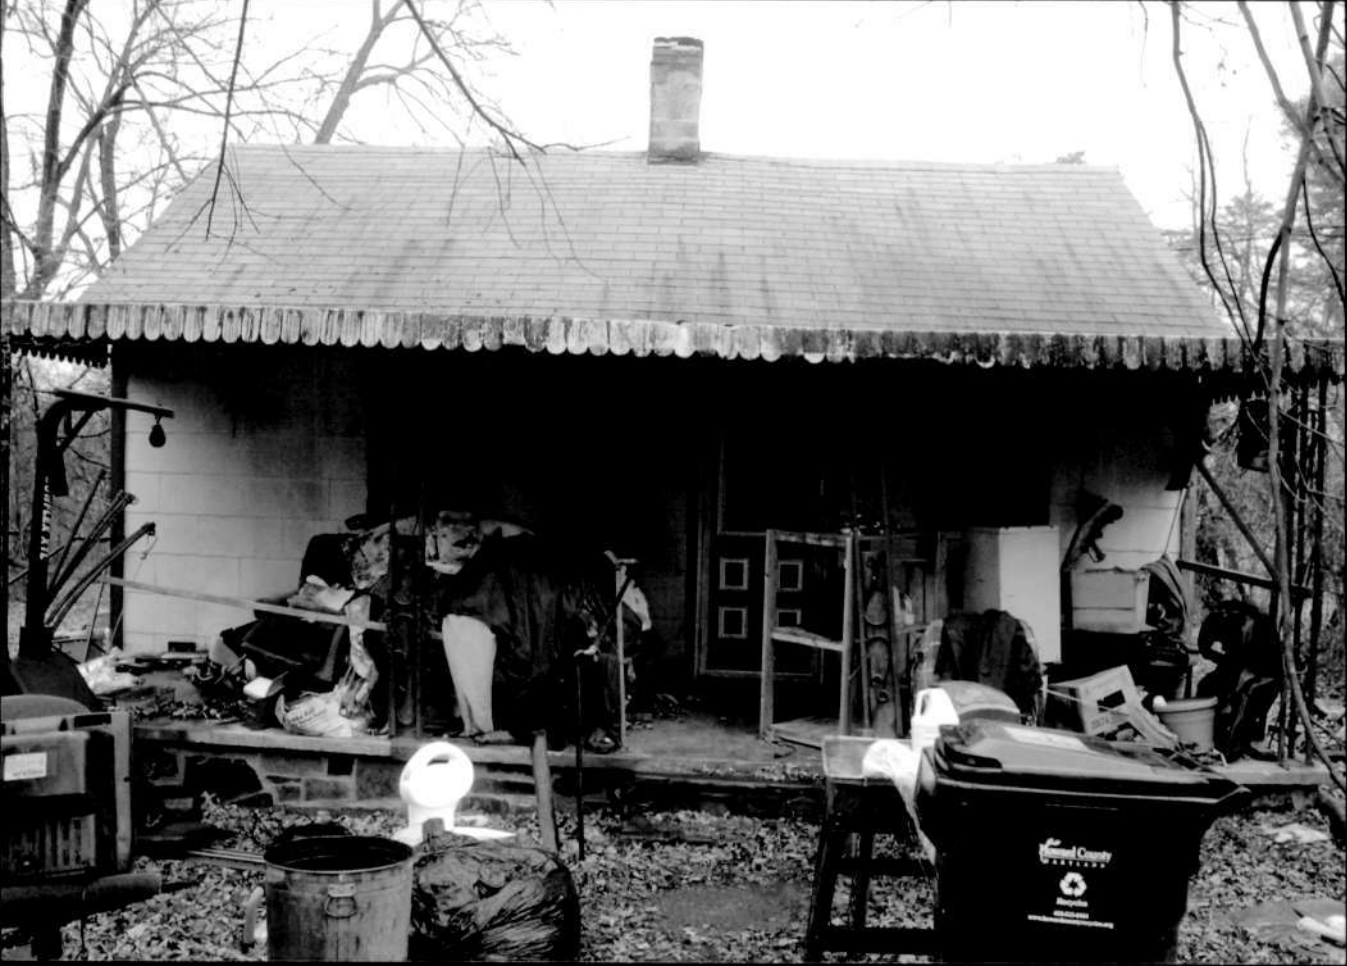
1 of 3

The southeast elevation has a door set just east of center with one light over four square panels. The end bays have a boarded-up window. There is a three-bay flat-roofed porch of aluminum with iron posts and a concrete deck on a stone-veneered foundation. The southwest elevation has a boarded-up window set just south of center, with a louvered vent in the gable end. The enclosed porch has a modern door and a boarded-up window. The northwest addition has a small one-light window set high on the wall of the northwest elevation, and the ell has a louvered vent in the gable end. The northeast elevation of the main block has a window set just east of center with a one-over-one sash, and a louvered vent in the gable end. The ell has a boarded-up window.

House, southeast elevation

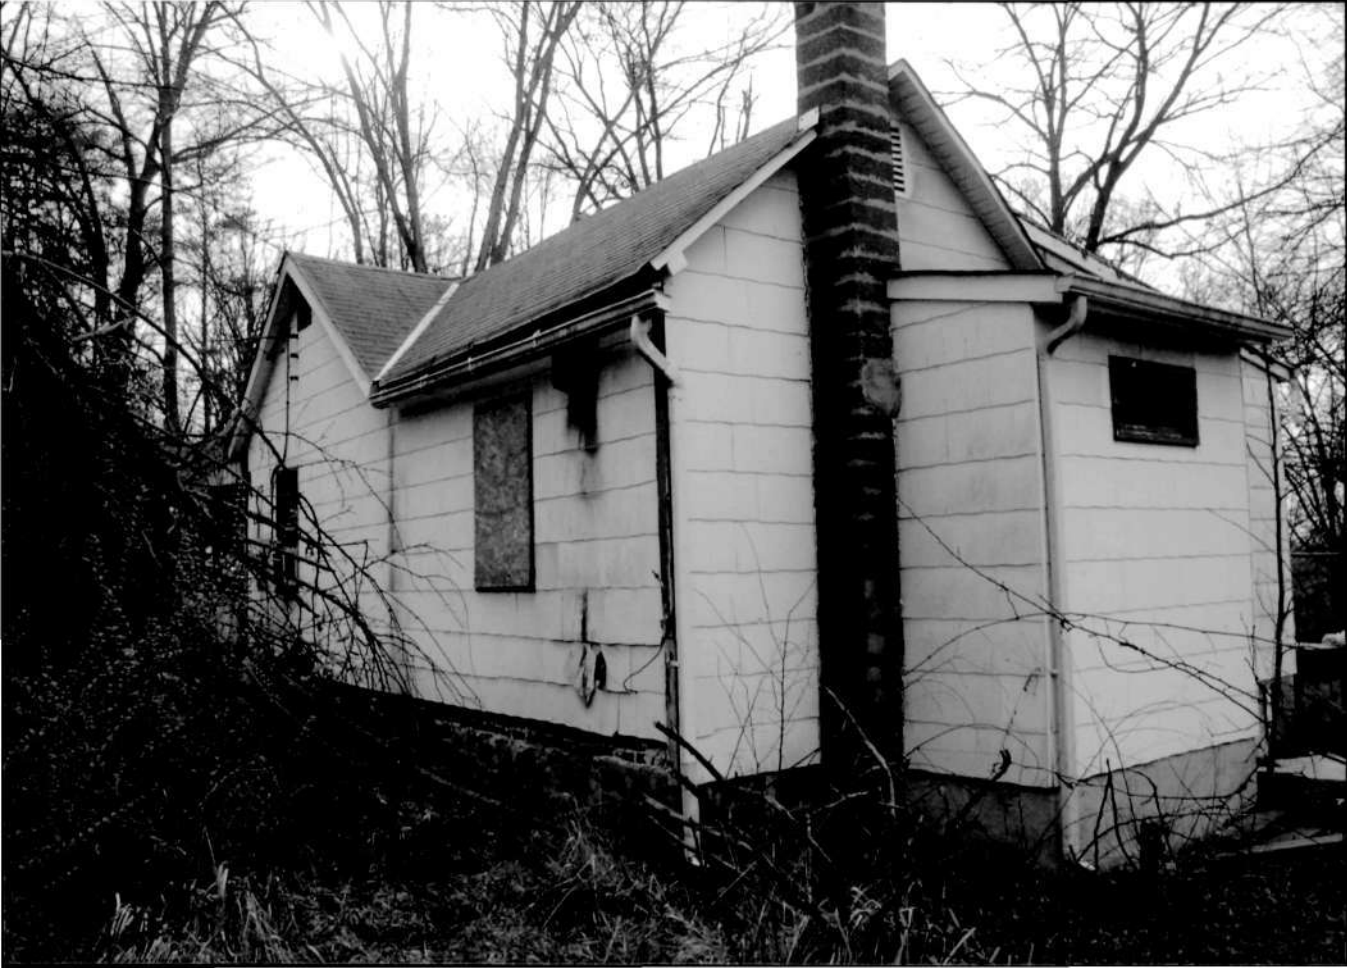
2 of 3

House, northeast + northwest elevations

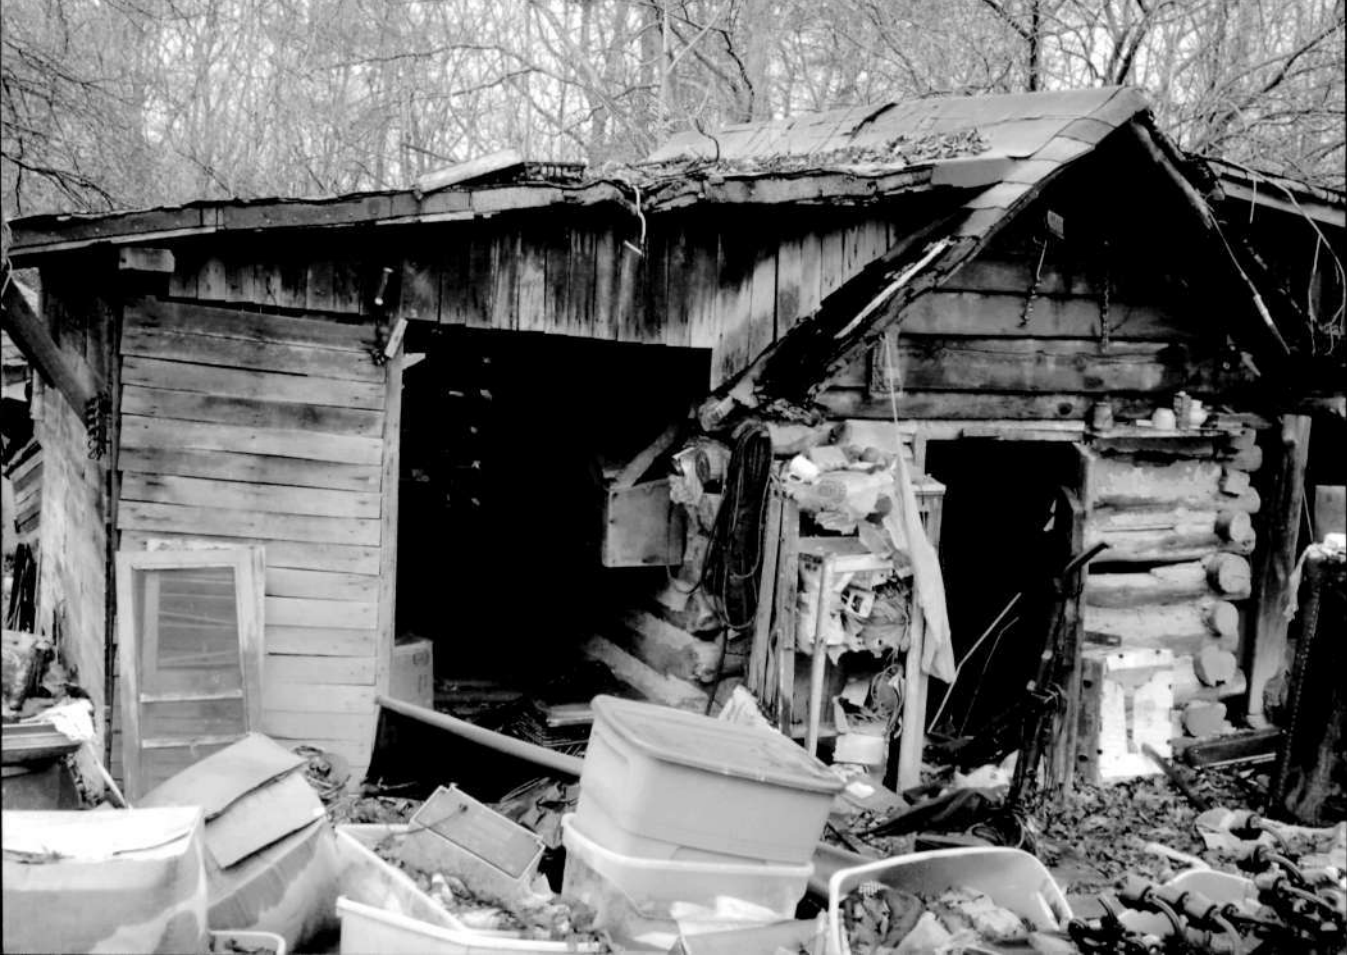
3 of 3

About 15 feet northwest of the house is a log outbuilding that is one story and one bay by one bay. It is built of round logs with saddle notches, and has a gable roof with asphalt shingles and a northwest-southeast ridge. The gable ends have wood weatherboards. The southeast elevation has a vertical board door. There are shed-roofed frame additions on the northeast, southwest, and northwest; the latter is mostly collapsed.

Outbuilding, southeast elevation
